Assessing Impact of Joint Actuator Failure on Lunar Rover Mobility

Catherine A. Pavlov, Arno Rogg, and Aaron M. Johnson

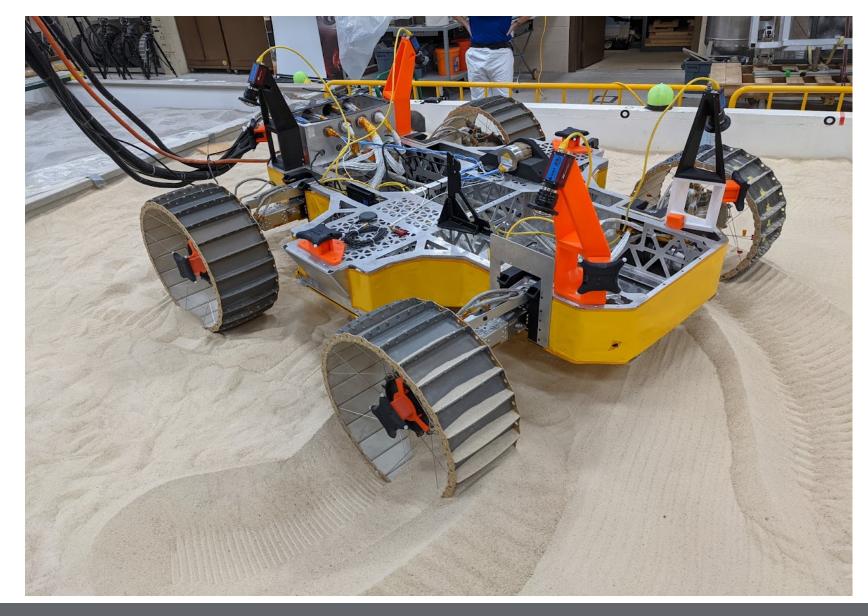
VIPER rover mobility prototype MGRU3

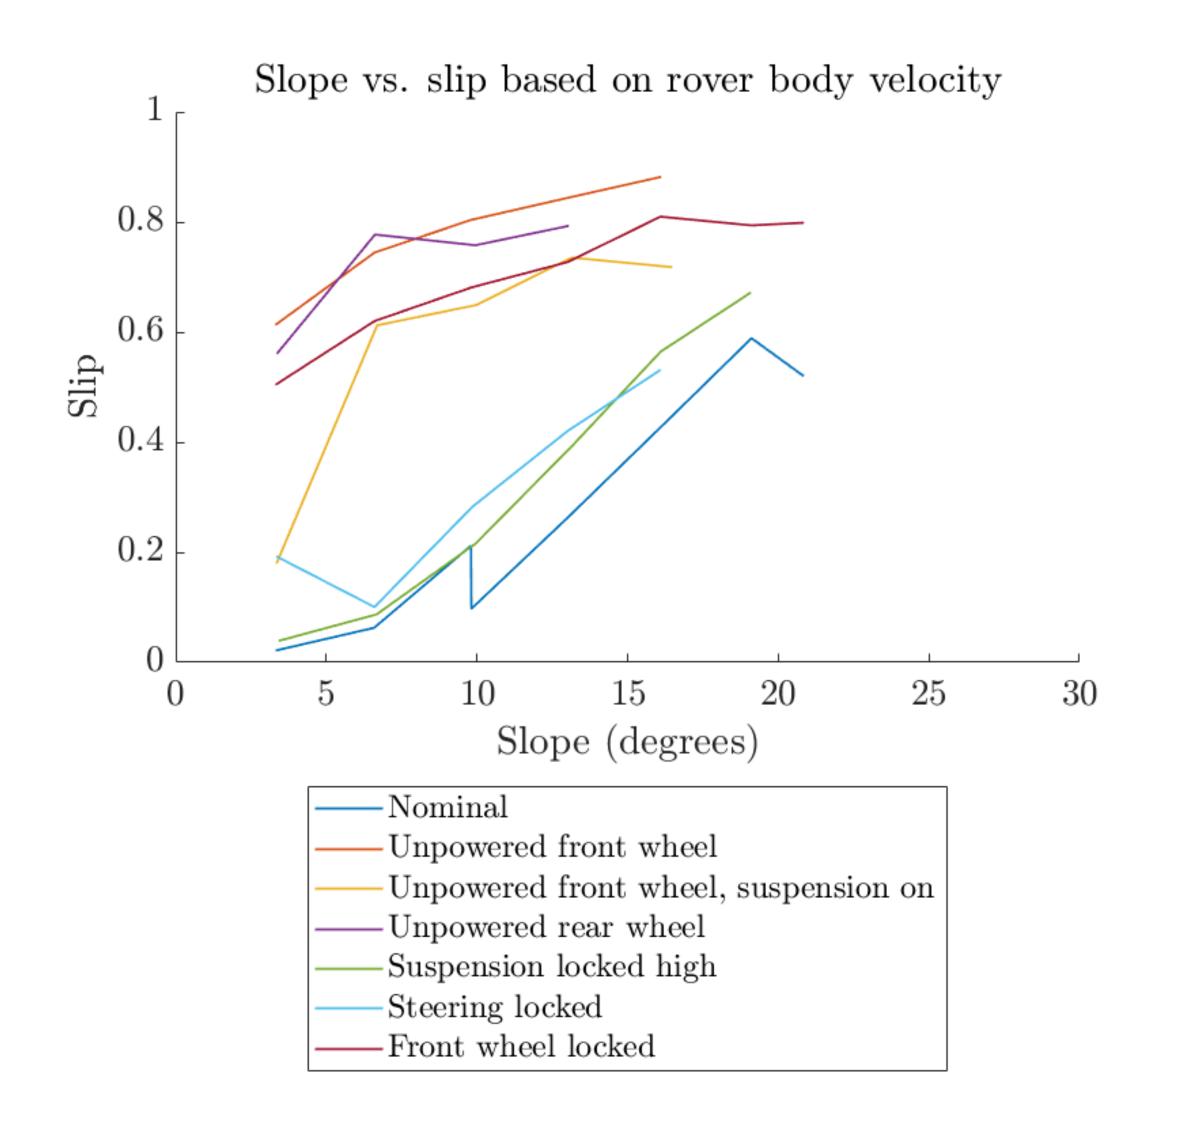
Loss of power to a drive motor was associated with a 200% increase in slip on slopes of 15 degrees, and a 25 x increase on shallow inclines of 3 degrees. Use of the suspension to balance forces on the wheels reduced slip on the 3 degree slope to 0.2 from 0.6 but had a more moderate impact on steeper slopes.

Locking a single suspension joint into a raised position only increased slip by 0-50%, with minimal impact on low angles. However, the tethered rig may be less representative of the actual impact here, as in free driving tests the rover rocked between opposite wheels. Locking a steering joint had similar impact on tractive ability, but with the rover unable to maintain a straight heading.

If a limit of 50% maximum slip is set as a limit for safe operation, VIPER can safely ascend slopes of 18 degrees with nominal performance and 16 degrees with a disabled suspension or steering actuator. With this limit, VIPER cannot safely drive with uncompensated loss of a drive actuator, but may be able to maintain some mobility on flat ground with proper control of the suspension.
